Memorandum

From: Michael L. MacWilliams, PE, PhD, and Aaron Bever, PhD, Anchor QEA, LLC

Re: Evaluation of the Potential Effects of Maintenance Dredging at Westpoint Harbor on Sedimentation at Greco Island

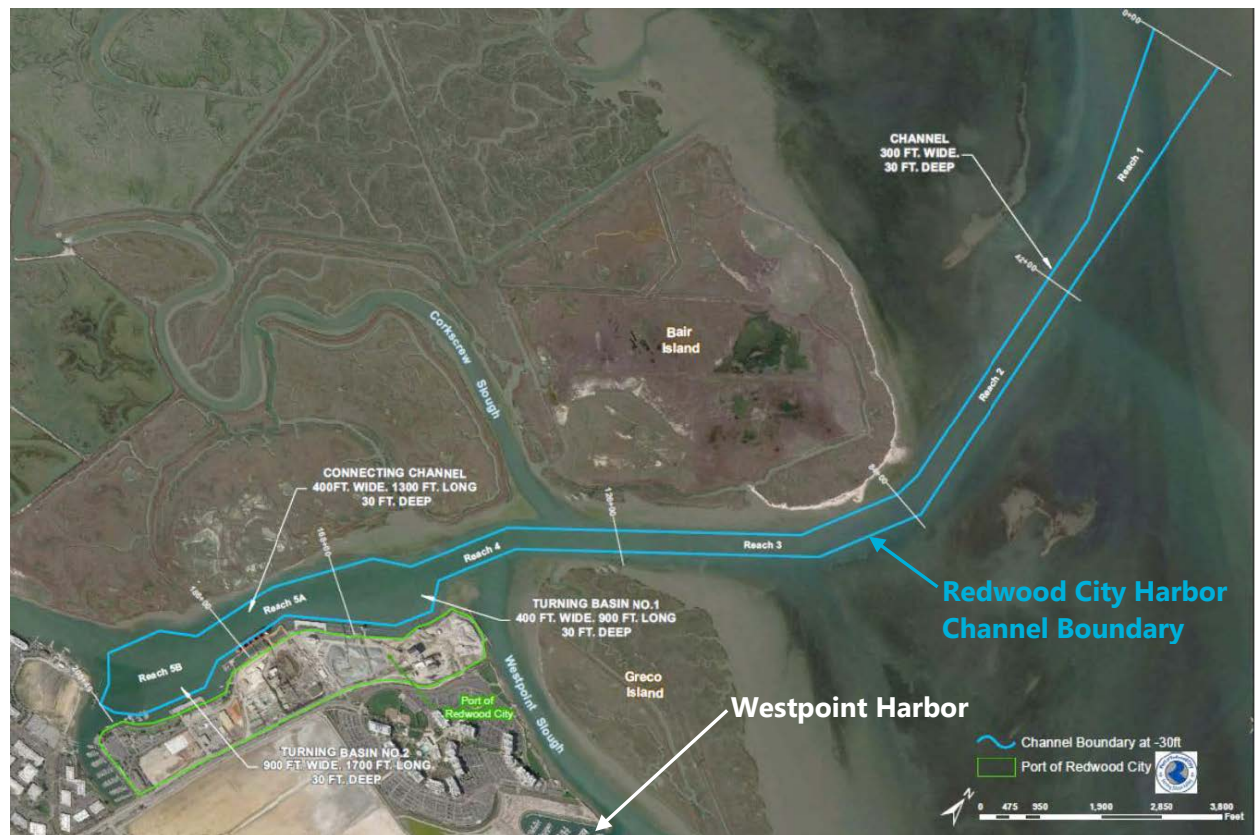
Figure 1
Redwood City Harbor Channel, Turning Basins, and Bair and Greco Islands

Note: A portion of Westpoint Harbor is visible in the bottom center of the figure.

In 2015, USACE, San Francisco District, prepared a feasibility report that describes the planning process for improving navigation efficiency at the Port of Redwood City, California (HydroPlan 2015). The recommended plan consisted of deepening the Redwood City Harbor and San Bruno Shoal Channels from -30 feet mean lower low water (MLLW) to -32 feet MLLW and slightly realigning the Redwood City Harbor Channel to avoid sensitive environmental features of Bair and Greco Islands (Figure 1). Due to the close proximity of the Redwood City Harbor Channel and Westpoint Harbor, the analysis conducted for Redwood City Harbor Channel Deepening study can be used to make inferences about the potential effects of dredging at Westpoint Harbor on adjacent islands.

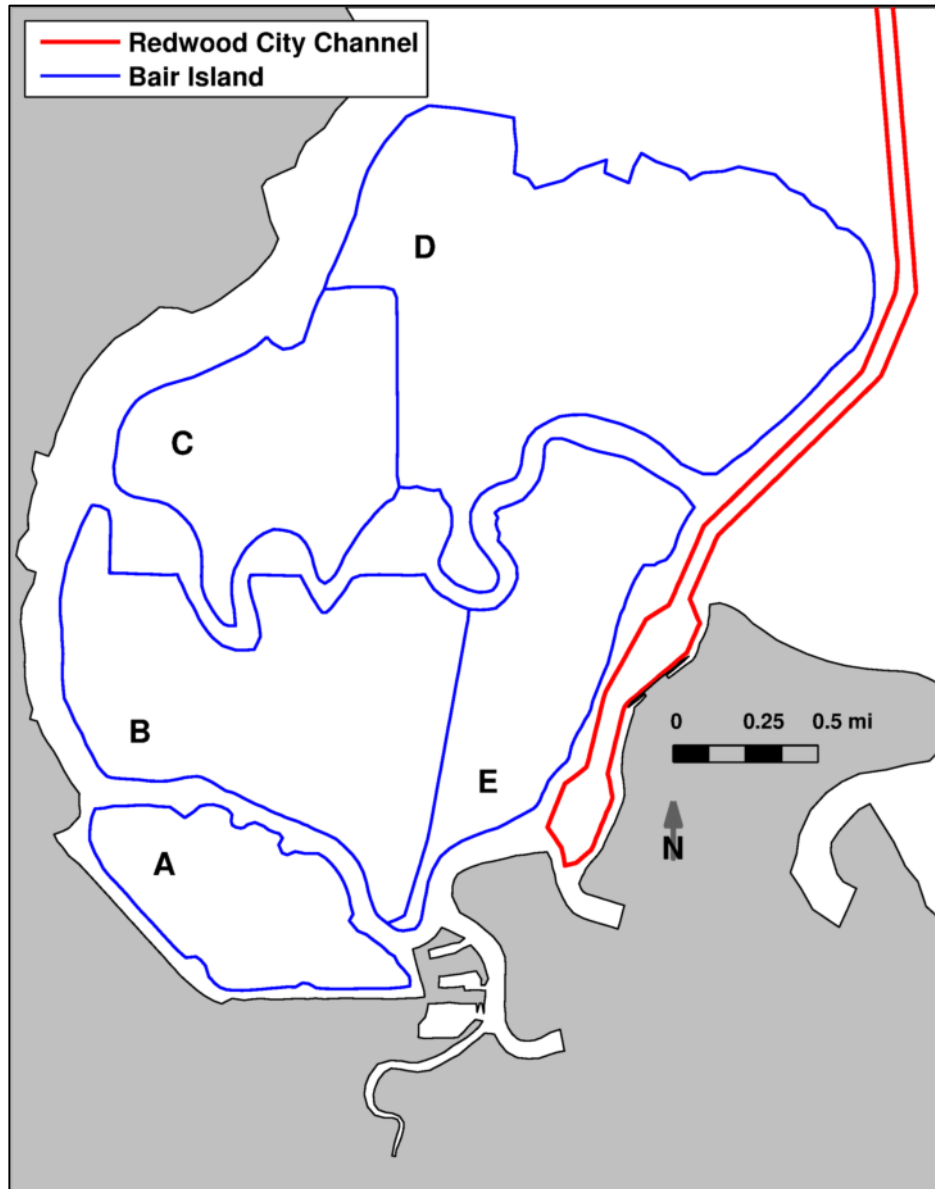
Figure 2

Outline of the five subregions of Bair Island considered in the calculation of sediment depositional volumes. The subregions are: (A) Inner Bair Island; (B) Middle Bair Island, (C) Outer Bair Island; (D) the Outer Bair Island marsh; and (E) the Middle Bair Island marsh

As part of the Redwood City Harbor Channel deepening study, a detailed 3-D hydrodynamic, wind wave, and sediment transport model was applied to evaluate sediment deposition in the Redwood City Harbor Channel and the San Bruno Shoal Channel under different project depths, evaluate whether the realignment of the channel could potentially decrease the above-grade shoaling, and evaluate the effects of the deepening of Redwood City Harbor Channel on hydrodynamics and sediment deposition in the vicinity of the Redwood City Harbor Channel and the adjacent Bair Island (Anchor QEA 2015). The change in sediment deposition thickness in five subregions of Bair Island surrounding the Redwood City Harbor Channel (Figure 2) was used to evaluate whether the mudflats and marshes surrounding the channel would be predicted to erode after deepening of the navigation channel. The model predicted that Bair Island would be net depositional during the simulated period, and that the increase in the project depth would have a negligible effect on the amount of sediment predicted to accumulate in Bair Island. Over a 1-year-long simulation period, the average sediment depositional thickness in each Bair Island region (Figure 2) was predicted to change negligibly (by less than 0.001 foot) after deepening from 30 feet MLLW to 32 feet MLLW (Anchor QEA 2015). This very small difference in the predicted sedimentation in Bair Island with increasing project depths indicates that deepening of the Redwood City Harbor Channel would not be expected to have a measurable effect on the net sediment deposition in Bair Island.

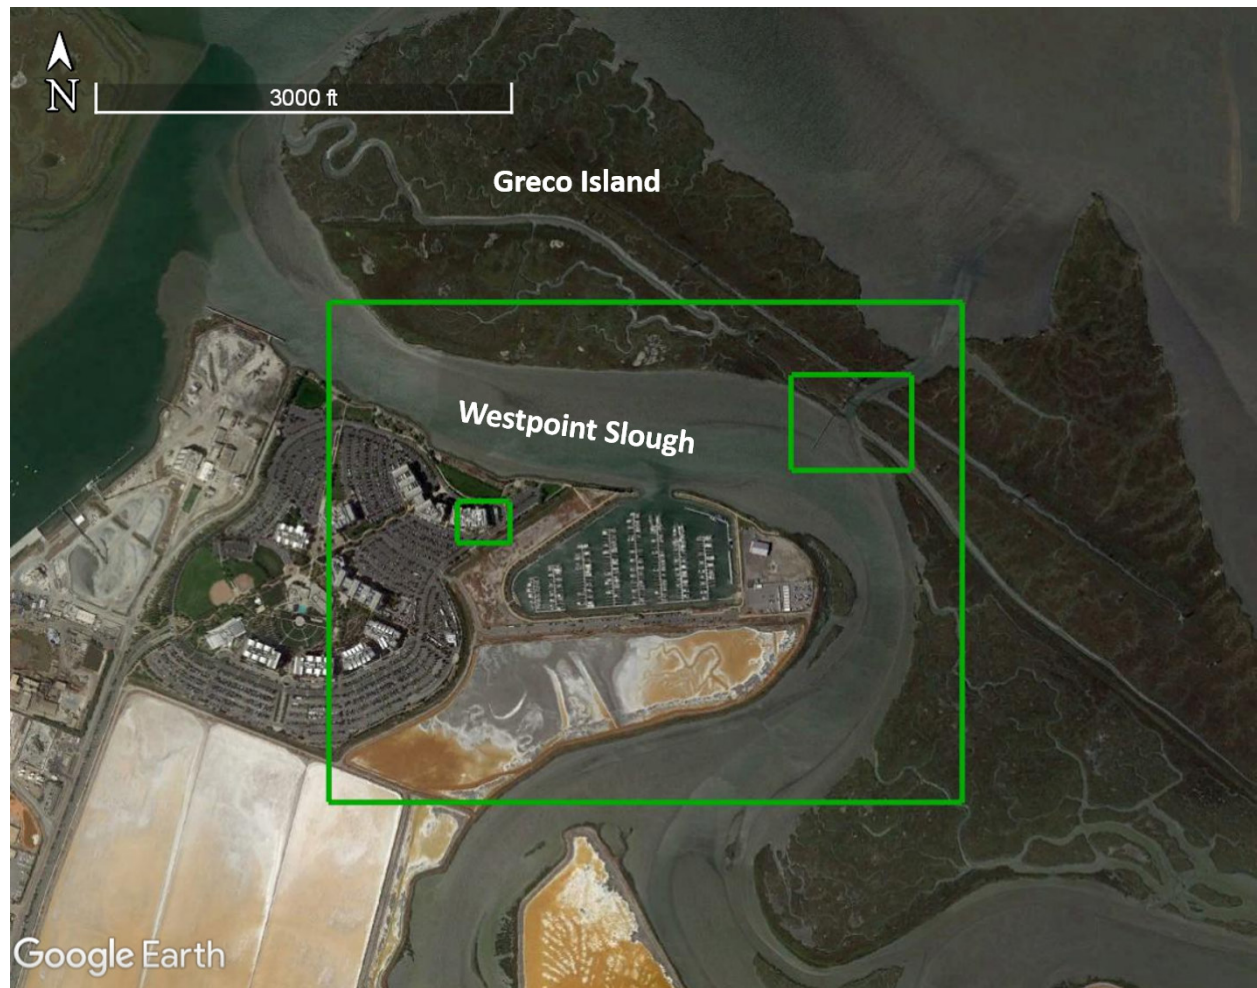
Figure 3
Greco Island in relation to Westpoint Harbor

Note: Green boxes outline the extent of the aerial images used for examining the Greco Island marsh vegetation edge (largest), change in the morphology of the channel through Greco Island (middle), and image position control lines (smallest).

Available aerial imagery collected between 2003 and 2018 was evaluated to assess changes to Greco Island that have occurred prior to and since the construction of Westpoint Harbor. Aerial imagery from Google Earth Pro was used to analyze the location of the Greco Island marsh vegetation edge through time, to determine whether the edge of the marsh vegetation has moved over time, and to better understand the cause of any erosion or accretion. Google Earth Pro is well suited for this analysis of the Greco Island marsh vegetation edge because it allows for the visualization of both past images and the most recent image. The edge of the Greco Island marsh vegetation can be traced on images collected over many years to evaluate whether the marsh vegetation has been eroding or accreting through time. This analysis focuses on four aerial photographs taken near low water when the mudflats were clearly visible between 2003 and 2018 (Table 1) and was limited to a region surrounding Westpoint Harbor (Figure 3).

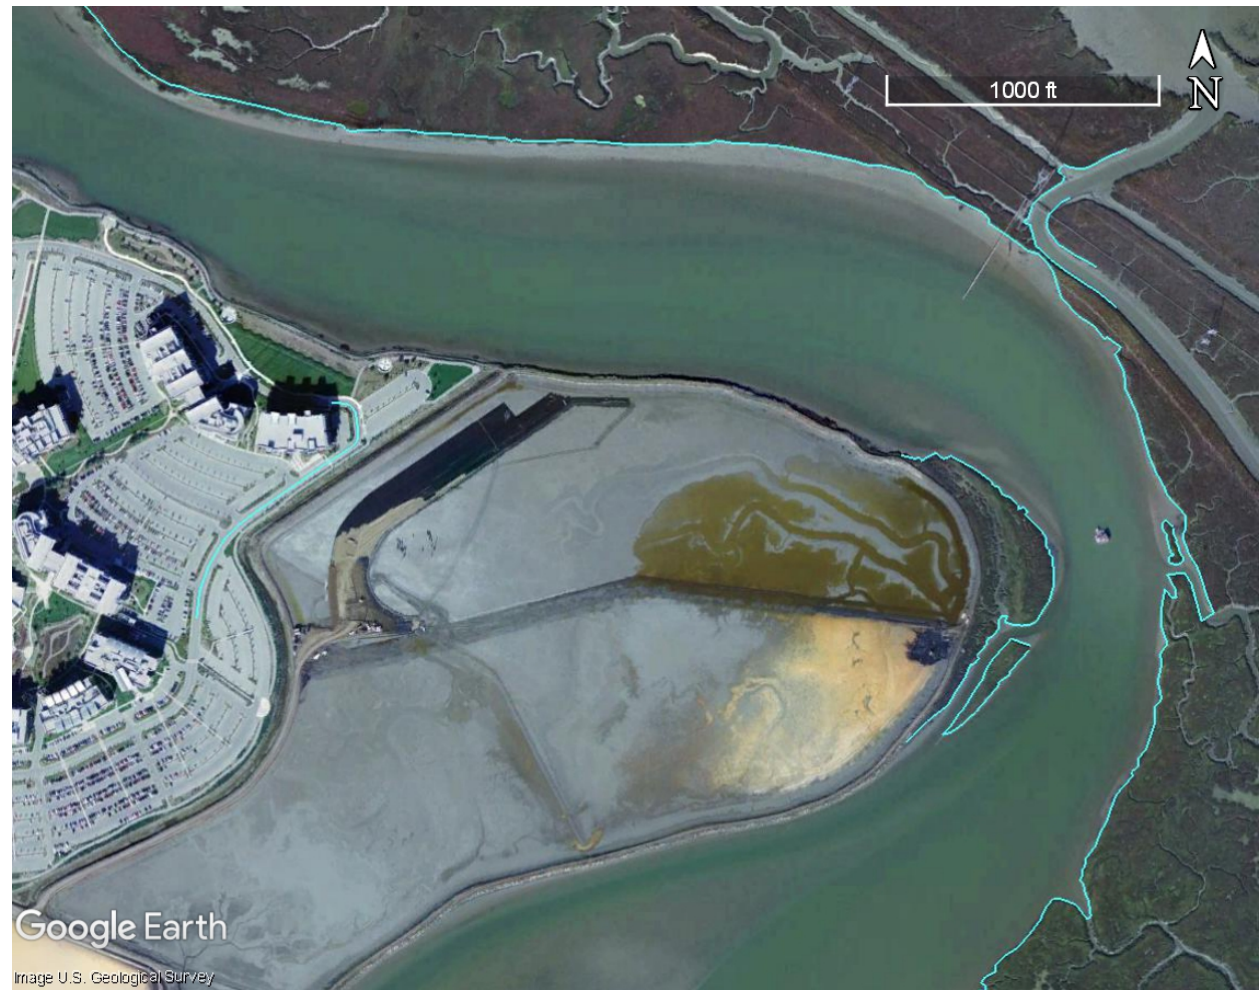
Figure 5
Aerial image and traced marsh vegetation edge (blue line) for December 13, 2003

Analysis of the aerial images through time suggests the position of the Greco Island marsh vegetation edge has been relatively constant since 2003, except for the area around the northeast-southwest trending channel through Greco Island. Figure 5 shows the position of the marsh vegetation edge in December 2003. Figure 6 shows the position of the marsh vegetation edge in June 2006. Figure 7 shows the marsh vegetation edge in May 2018. The estimated position of the marsh vegetation edges in all 3 years is shown together with the May 2018 aerial photograph on Figure 8. The location of the marsh vegetation edge changed minimally from 2003 to 2018 northwest and southeast of Westpoint Harbor. In these regions, the shift in the location of the marsh

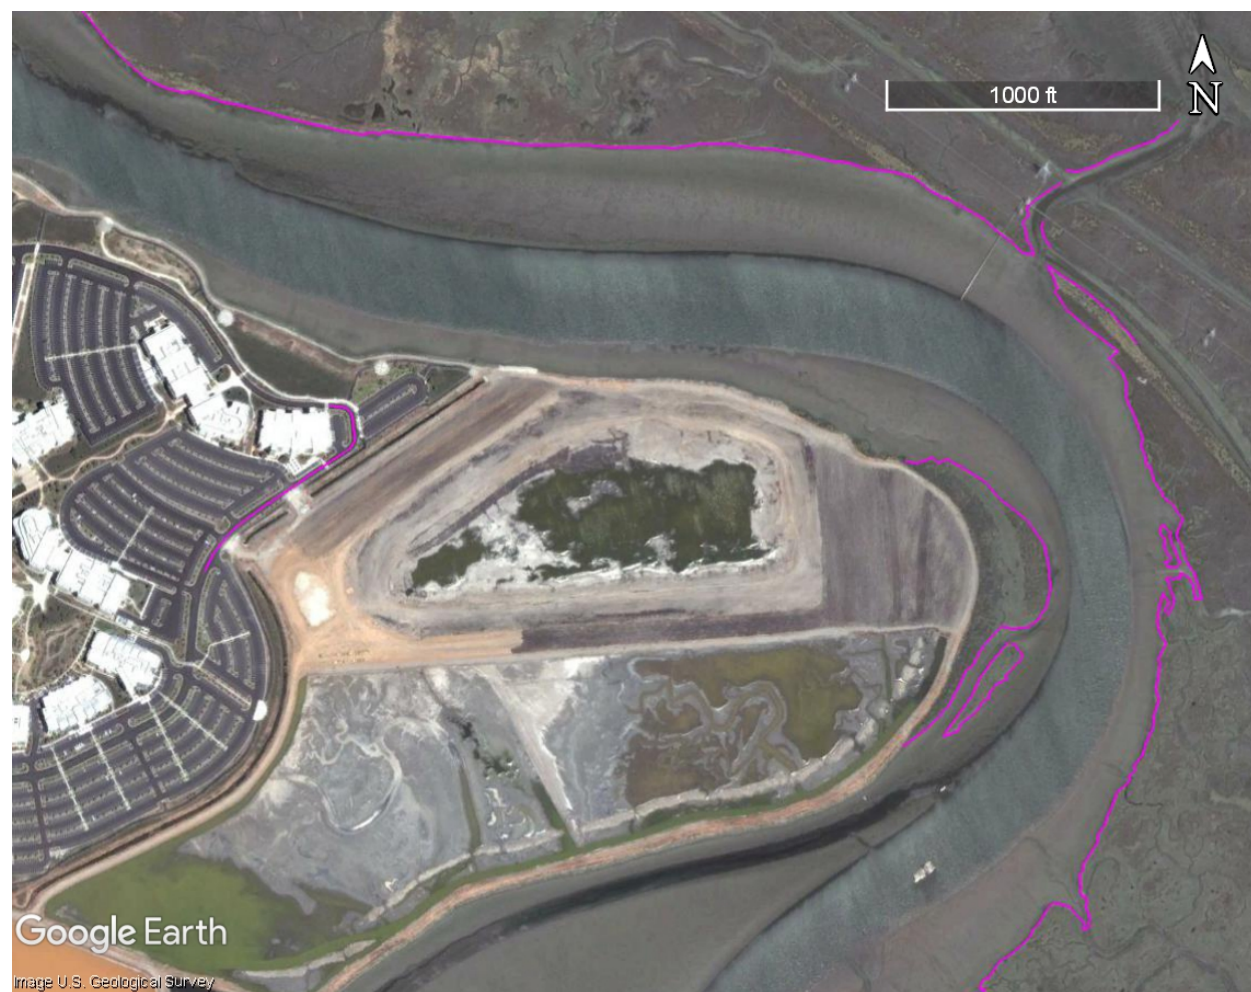
Figure 6
Aerial image and traced marsh vegetation edge (purple line) for June 16, 2006

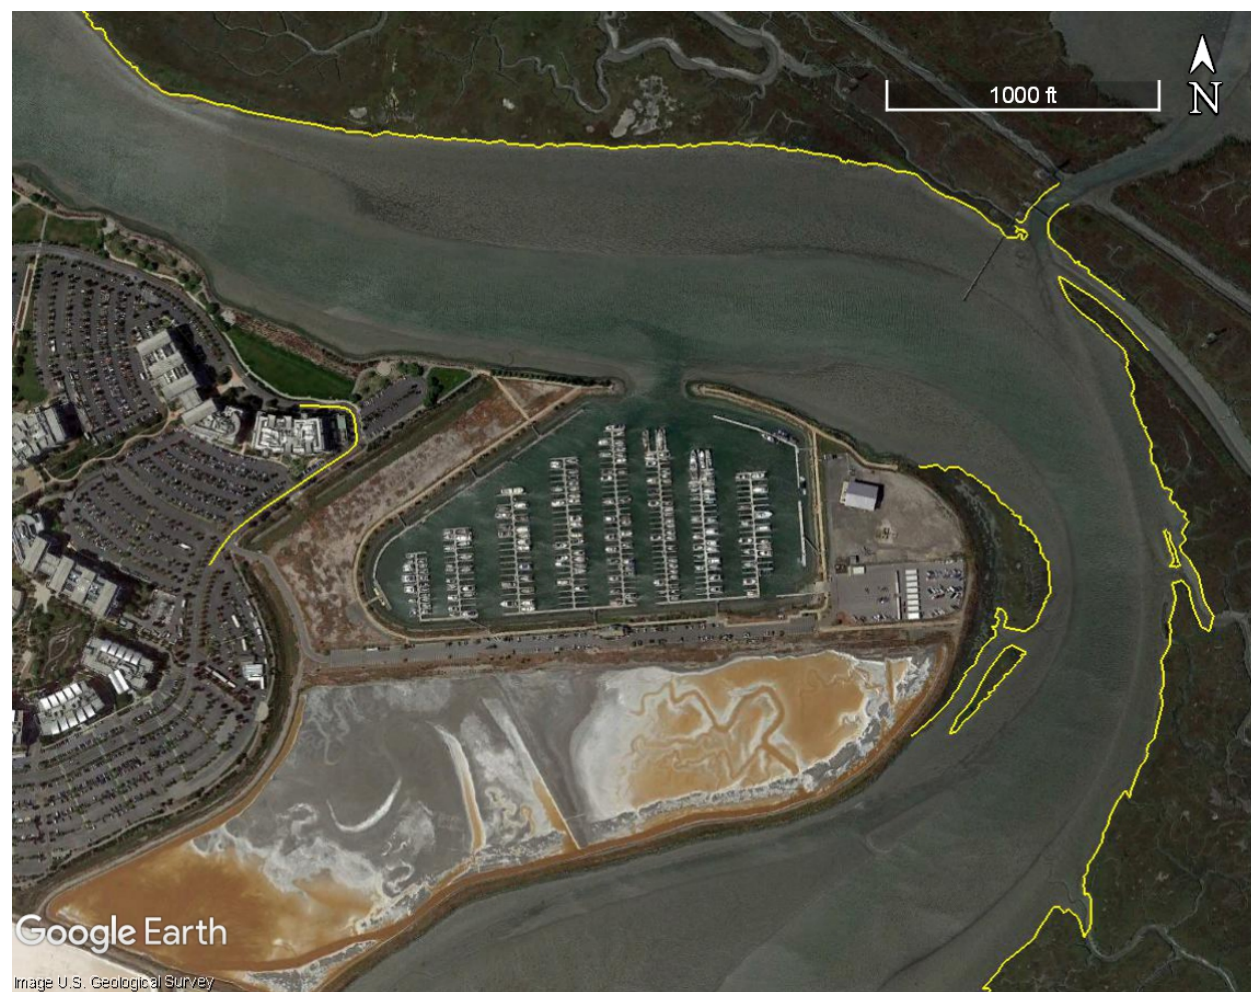
Figure 7
Aerial image and traced marsh vegetation edge (yellow line) for May 9, 2018

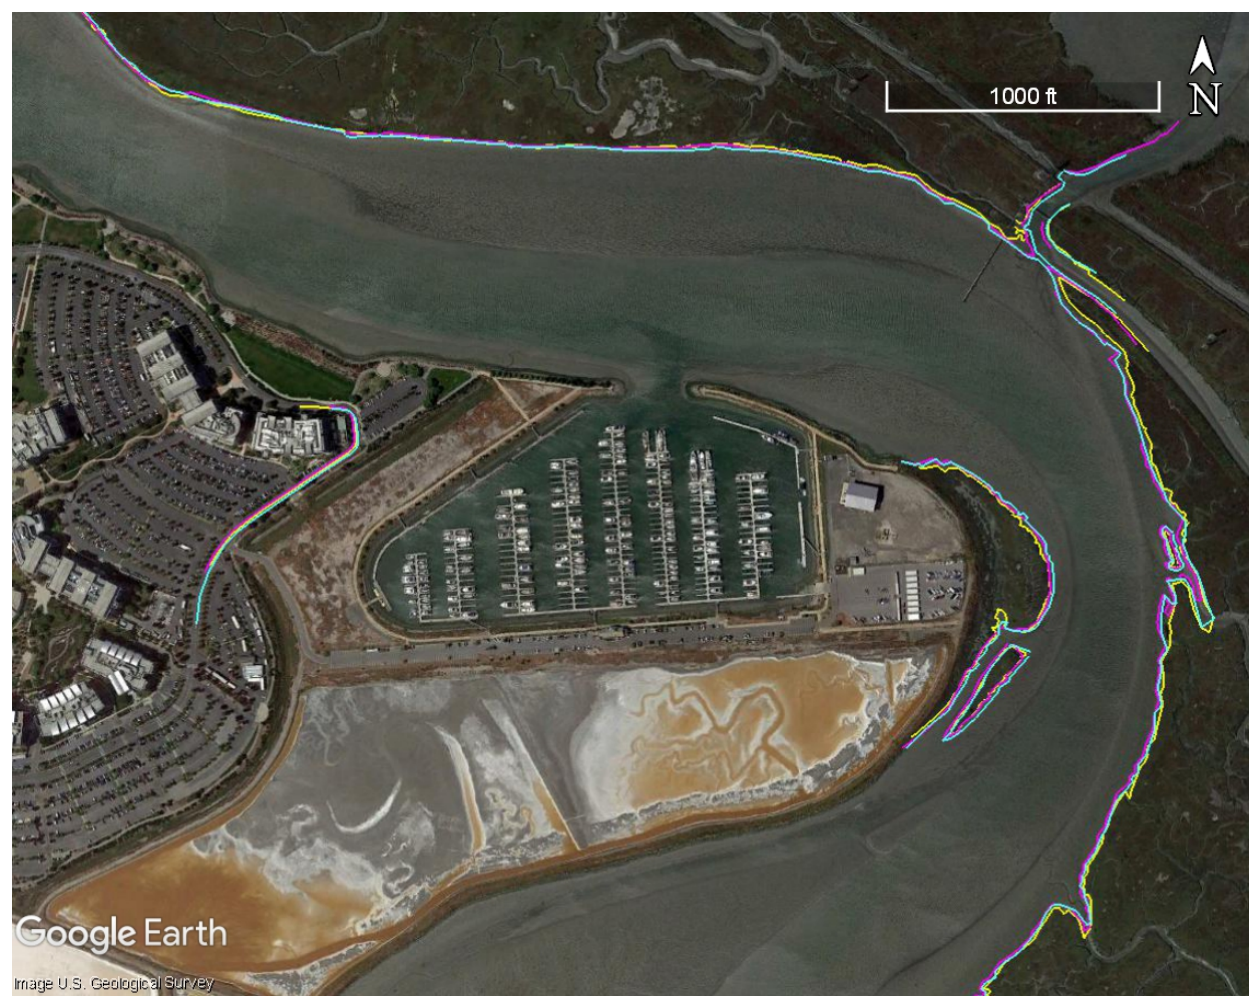
Figure 8
Aerial image for May 9, 2018 and traced marsh vegetation edge for the 2003, 2006, and 2018 images

- 2003 Marsh Edge
- 2006 Marsh Edge
- 2018 Marsh Edge

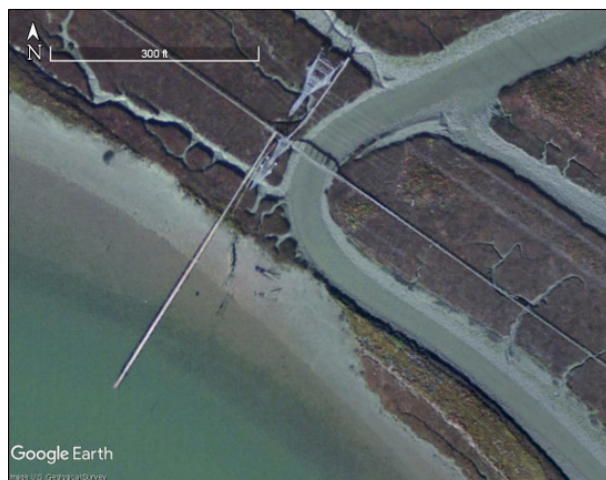
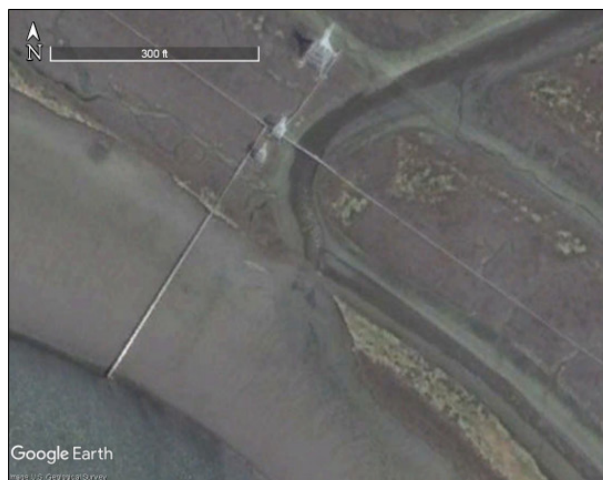
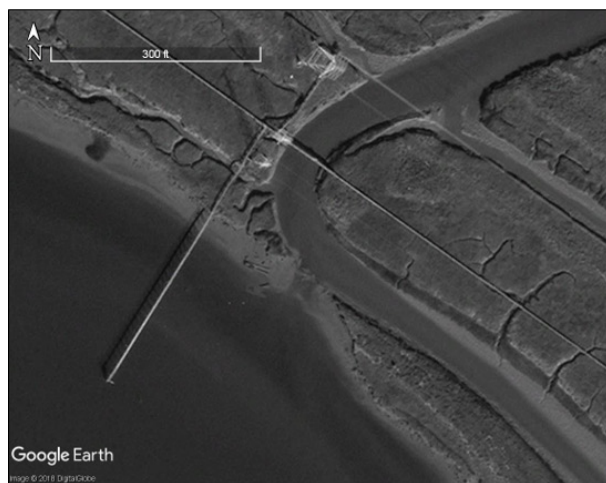
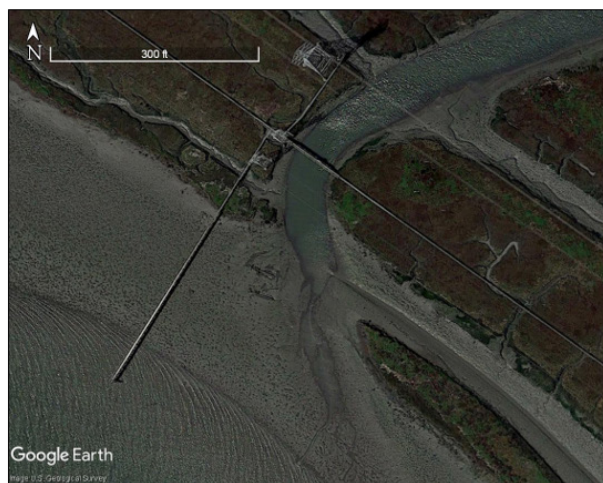
Figure 9

Aerial images focusing on the area where the northeast-southwest trending channel through Greco Island now connects to Westpoint Slough

However, northeast of Westpoint Harbor near the connection between the northeast-southwest trending channel through Greco Island and Westpoint Slough, the position of the marsh vegetation edge indicates that the marsh vegetation has eroded since 2003. A set of four aerial images centered around where the change in the marsh vegetation has been the largest between 2003 and 2018 was used to understand how the morphology has changed through time and estimate the primary cause of the erosion of the marsh edge. These four aerial images demonstrate that the channel through Greco Island did not connect directly to Westpoint Slough in 2003 (Figure 9, top left). In 2003, a small strip of marsh vegetation separated the channel through Greco Island from Westpoint Slough and the channel took a 90-degree turn near Westpoint Slough. It would not be unusual for the outside of a bend (the southwest side closest to Westpoint Slough) to erode as water flows through a channel. By 2006, water from the channel was beginning to flow into Westpoint Slough depending on the tidal stage but the channel still largely followed the 2003 alignment. The narrow marsh separating the channel and Westpoint Slough that was visible in 2003 had eroded by 2006 (Figure 9, top right) and the channel through Greco Island connected more directly to Westpoint Slough. This change occurred before construction of Westpoint Harbor. Between 2008 (Figure 9, lower left) and 2018 (Figure 9, lower right), the edge of the marsh vegetation near this channel connection to Westpoint Slough continued to erode as the channel through Greco Island continued to widen.

This analysis suggests that the largest morphologic change to Greco Island in the vicinity of Westpoint Harbor between 2003 and 2018 was the opening of the direct connection between Westpoint Slough to the channel through Greco Island. However, this change initially occurred between 2003 and 2006, prior to the construction of Westpoint Harbor. In the portions of Greco Island directly across from the entrance to Westpoint Harbor, the marsh vegetation did not change significantly between 2003 and 2018. This suggests that, within the uncertainty of the aerial photograph alignments, the harbor itself is not having a significant effect on adjacent marsh areas because the closest marsh areas to the harbor have not changed over the period evaluated.
